INSPECTION OF PATHOLOGICAL MANIFESTATIONS WITH EXECUTION OF DAMAGE MAP IN FACADES: CASE STUDY IN BLOCK G OF POLYTECHNIC SCHOOL OF PERNAMBUCO

José Maria de Moura Júnior and Yêda Vieira Póvoas

Escola Politécnica de Pernambuco, Universidade de Pernambuco, Rua Benfica, 455, Madalena, Recife-PE, 50720-001, Brasil

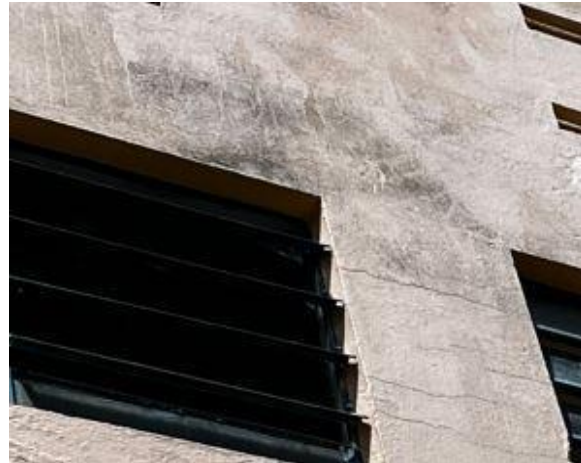
It was possible to verify dirt on the upper part of the facade in large amounts, although of low In addition, small stains were also observed around the windows, some at the top as seen in Figure 2,

Figure 2. Dirt on the top of a window of the front facade of block G

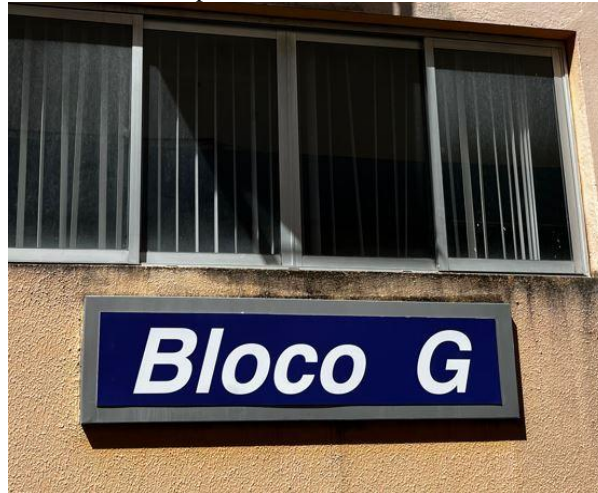
others at the bottom and a more concentrated amount between a window at the bottom of the block that is above the identification sign (figure3).

Figure 3. Dirt between plate and window of the front facade of block G

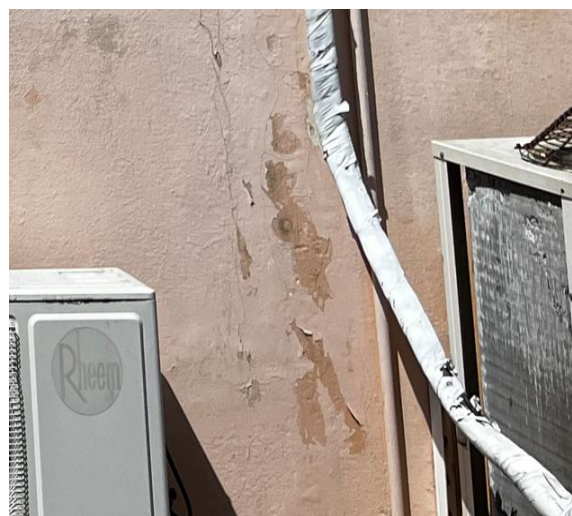
In some parts of the facade there was detachment of the painting, such as the region between the air conditioning boxes (Figure 4) and on a corner pillar on the extreme right side of the structure (Figure 5).

Figure 4. Paint detachment

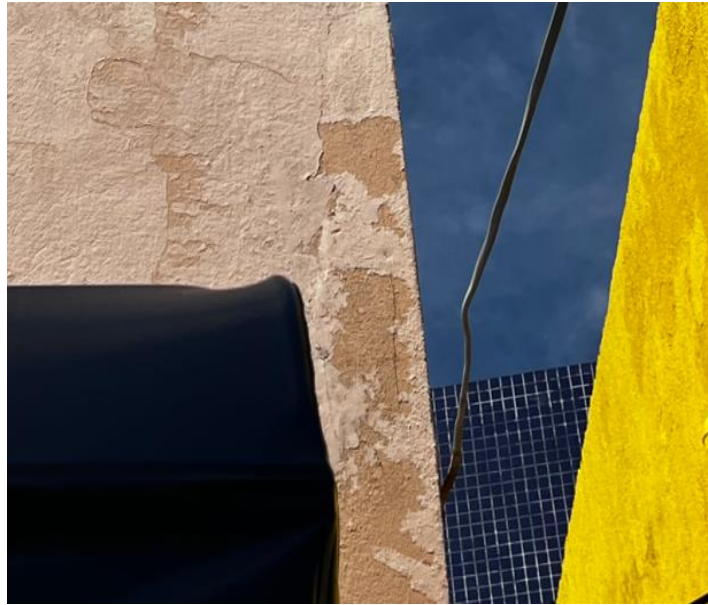
Figure 5. Paint detachment on the abutment

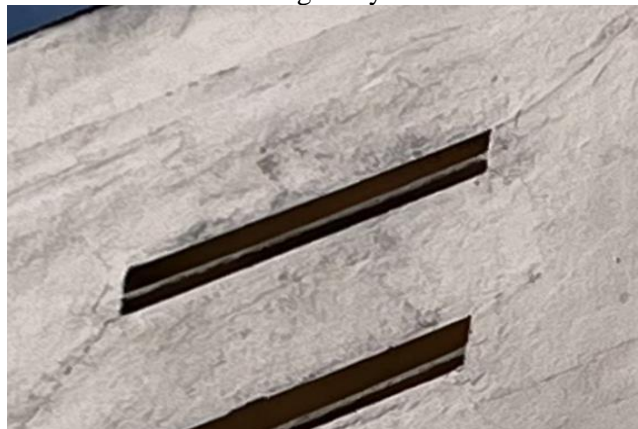
In the upper part of the facade there are some openings with some 45° cracks starting at their vertices (Figure 6). This type of crack occurs, according to Thomaz (2020), due to the action of the loads, because of the path of the compression isostatic. Another hypothesis raised by the author is the differentiated settlement due to the lack of homogeneity of the soil.

Figure 6. 45° crack in the front facade of the G block

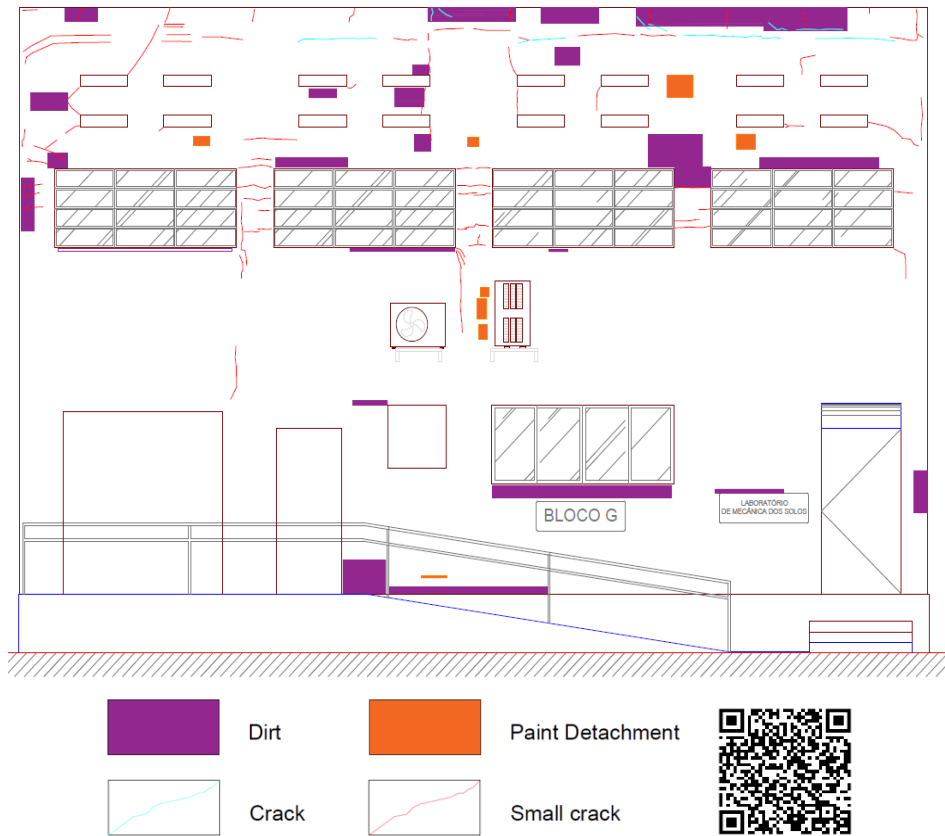
The damage map of the front facade of block G was represented as Figure 7. Although it presents several points of dirt, it is emphasized that the level of dirt is low. It is possible to say that the facade of this block is in good condition, despite having some pathological manifestations. Also noteworthy is the presence of various types of cracks along the facade.

Figure 7. Damage map of the front facade of block G

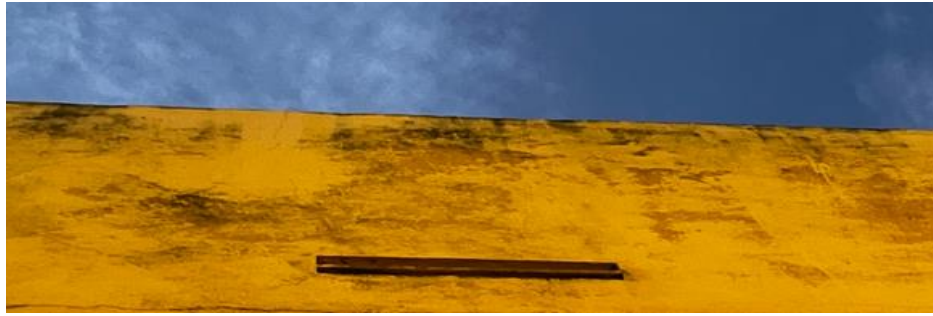
This facade presented dirt, mainly on the upper part (Figure 9). In addition, this pathological manifestation was also identified near the left pillar and at the base of the structure.

Figure 9. Dirt on the upper part of the right side facade of block G

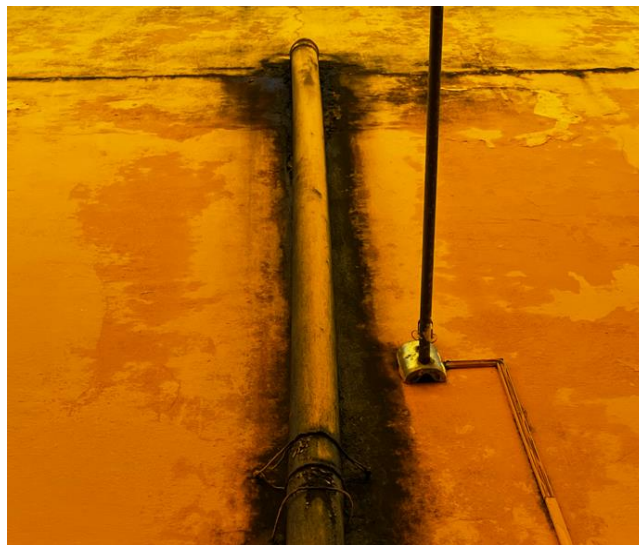
In the central region of the facade there is an external pipe that runs from the garden at the bottom to almost the top of the facade. There was dirt around the pipe (Figure 10), probably caused by some leakage at the top.

Figure 10. Dirt on the right side facade of block G

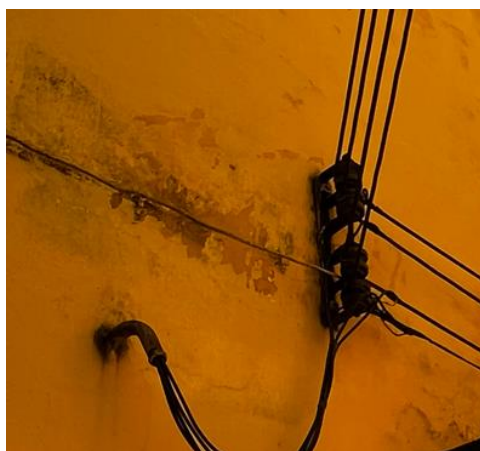
Along the facade, paint detachment was verified, as in Figure 11, which shows the detachment near the left end pillar, and in Figure 12, which shows it near the garden. In addition, other points were verified, seen in the damage map at the end.

Figure 11. Paint detachment on the facade

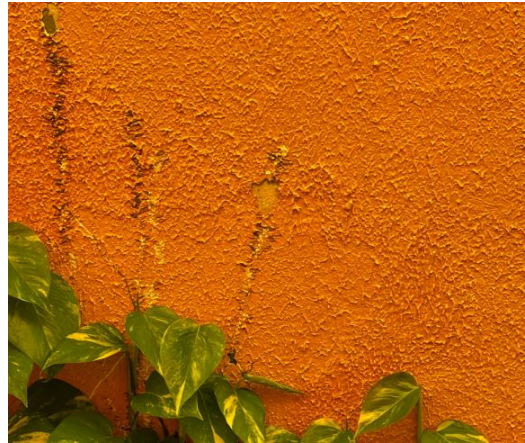
Figure 12. Paint detachment on the base

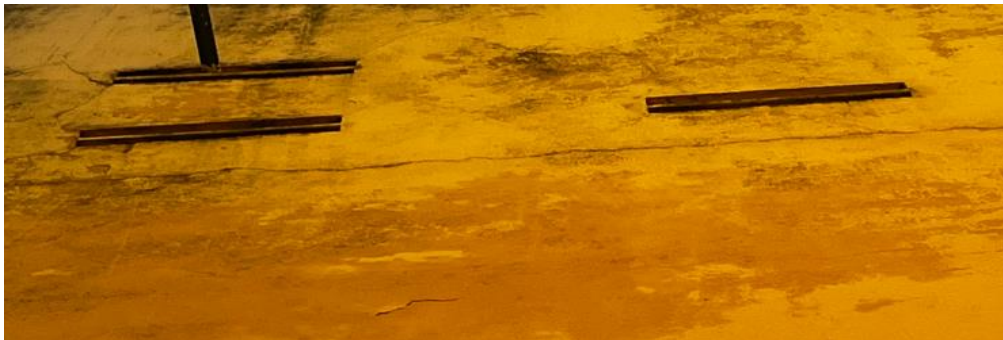
A horizontal crack was observed on the upper part of the facade that runs along the entire length of the structure (Figure 13). The crack is above the window, possibly at the structure-masonry interface, between the beam and the masonry.

Figure 13. Horizontal crack that runs along the entire length of the side facade of block G

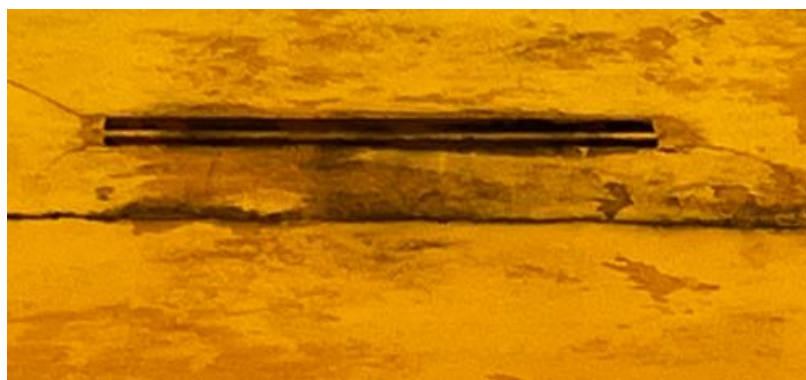
As on the previous facade, 45% cracks were found in the openings on the upper part of the facade (Figure 14 and 15), some with greater length than others.

Figure 14. 45° crack in opening in the right side facade of block G

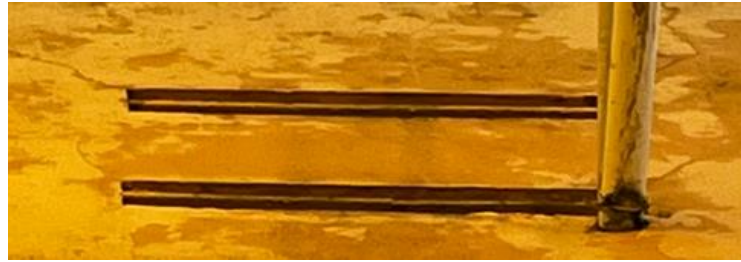
Figure 15. 45° crack in two openings in the right side facade of block G

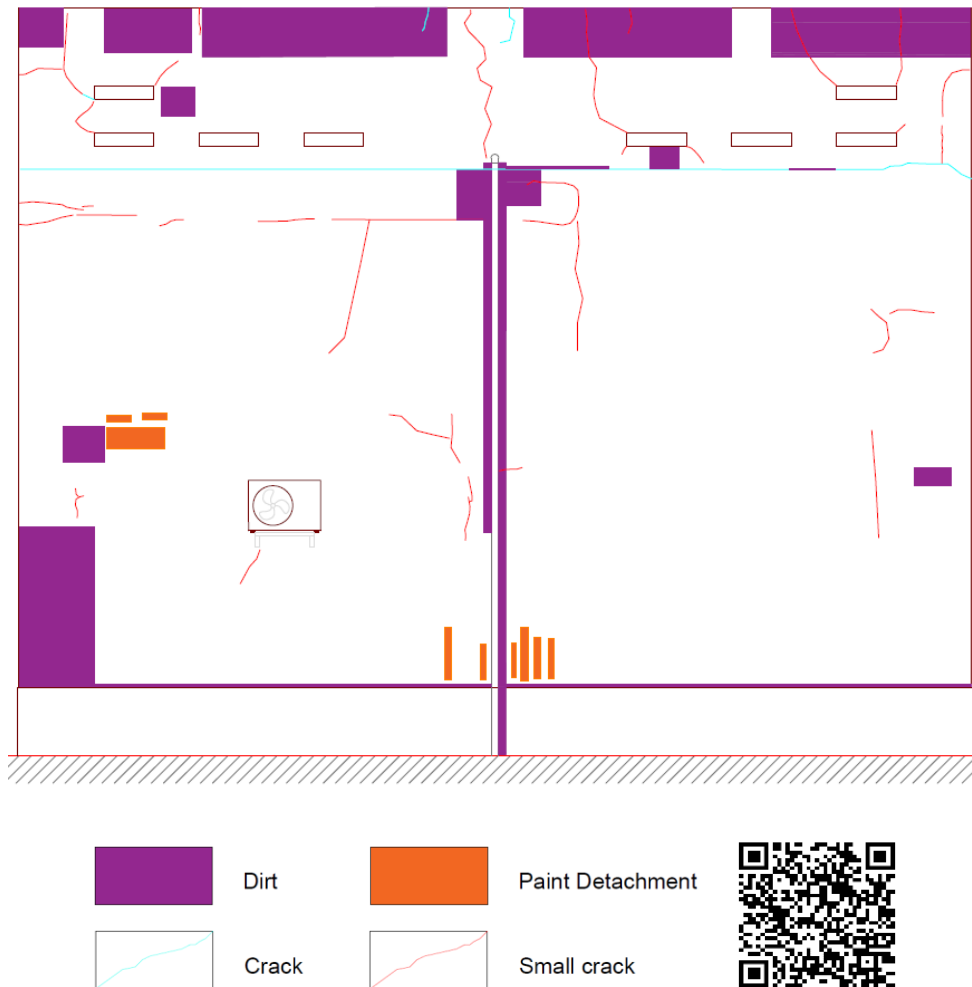
The damage map of the right side facade of Block G can be seen in Figure 16, which represents the pathological manifestations found. As mentioned previously, this facade has a narrow passage that made photographic records difficult, thus making it difficult to draw up the damage map. Like the front facade, the dirt stains found were mild, with the exception of the region near the central pipe and at the base of the facade. Cracks were found along the facade, especially diagonal cracks found in the openings at the top.

Figure 16. Damage map of the right side facade of block G

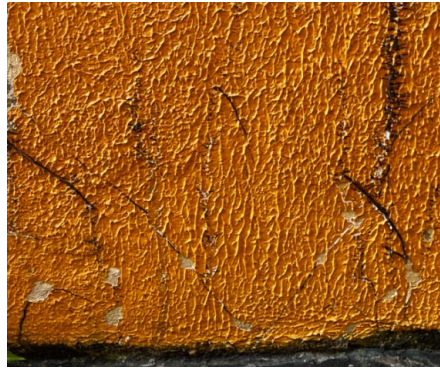
Along the facade it was observed detachment of the paint, especially in some points near the garden (Figure 18), located at the bottom of the facade.

Figure 18. Paintwork detachment on the left lateral facade of block G

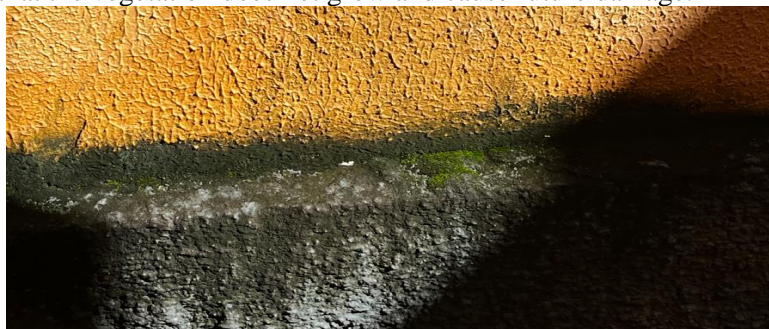
It was observed near the garden the action of biodeterioration with the presence of mold and mildew and also the presence of vegetation (Figure 19), although in an early stage. Maintenance is recommended so that the vegetation does not grow and cause future damage.

Figure 19. Vegetation, mold and mildew present on the left side facade of block G

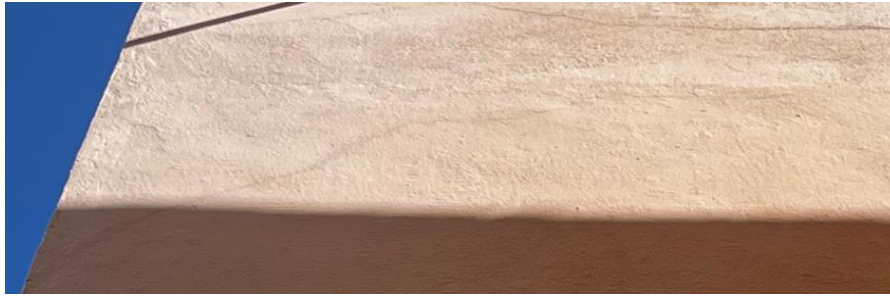
At the top of the facade, horizontal cracks were observed running along its entire length, as seen in the damage map at the end. The ends, both right and left, had an almost 45° inclination of these cracks. It is possible that these cracks occurred at the masonry-structure interface, influenced also by the action of thermal movements that detached the parapet. Figure 20 shows these cracks on the left edge of this facade.

Figure 20. Cracks in the upper part of the left lateral facade of block G

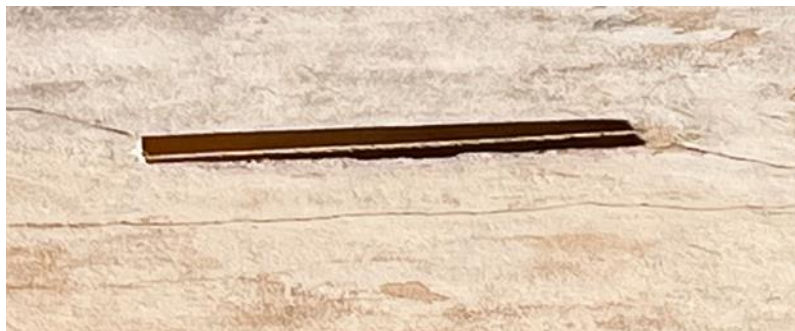
As with the previous facade, several 45° cracks were found in the openings on the upper part of the facade (Figure 21). Due to the difficulty of photographing this facade, it was not possible to obtain many clear images of this problem. However, the damage map depicts all the points that present this pathological manifestation

Figure 21. 45° crack in the left lateral facade of block G

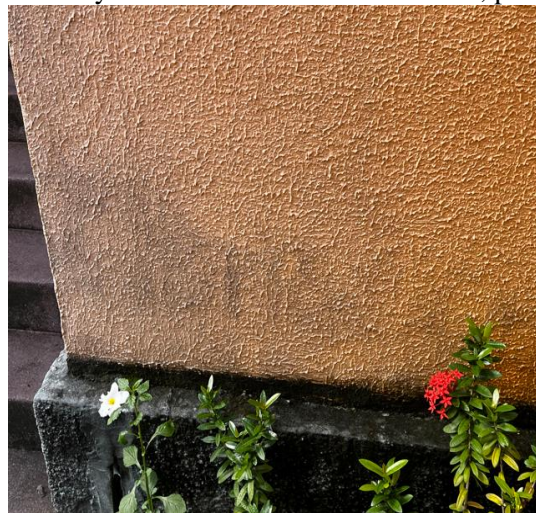
This facade presented dirt spots, mainly in the upper part, but also in some points of the base, as in Figure 22. However, it is noteworthy that the stains were not so dark, presenting low intensity.

Figure 22. Dirt on the left side facade of the block G

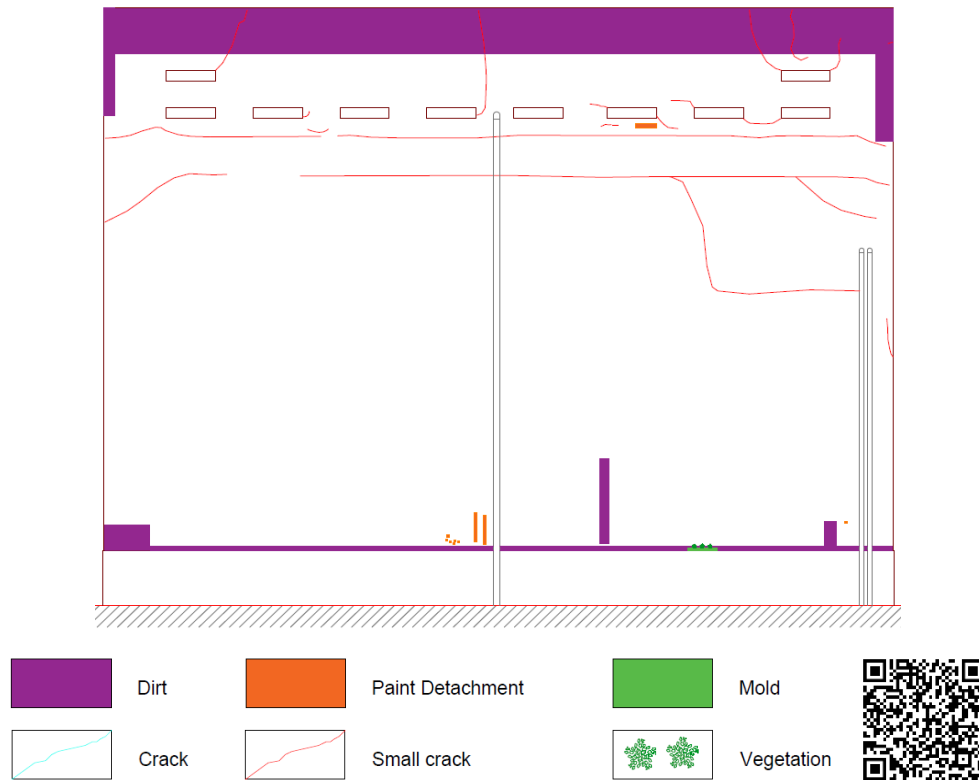
The left side facade of block G is in good condition and the pathological manifestations present can be seen in the representation of the damage map (Figure 23). Despite presenting dirt stains all over the upper part of the facade, the level of dirt is not high. It is also noteworthy that this facade did not present as many cracks as the previous facades.

Figure 23. Damage map of the left lateral facade of block G

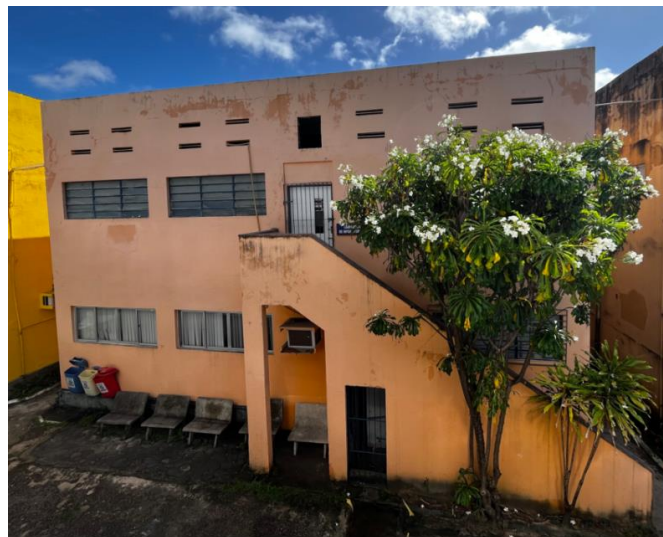
The posterior facade (Figure 24) does not suffer as much from the action of rainfall, since its upper part has almost no dirt stains. If compared to the previous facades, this one is in excellent condition in relation to this pathological manifestation. However, even so, some detailed points were identified on the damage map.

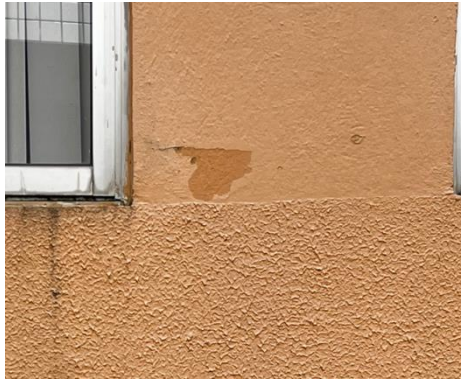
Some points were observed where the paint was detached (Figure 25), possibly justified by the fact that this facade has less contact with the action of rain.

Figure 25. Paintwork detachment on the posterior facade of block G

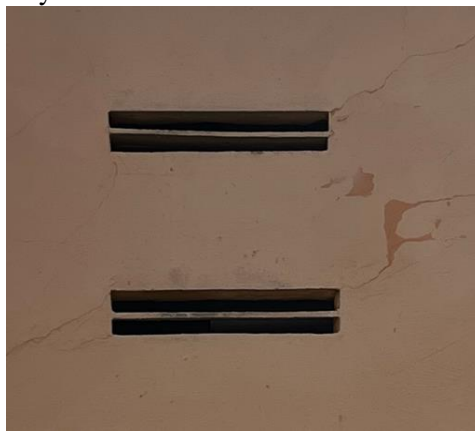
This facade, as well as the other facades of this block, has 45° cracks (Figure 26) in the openings on the upper part, probably formed by the action of loads on the structure.

Figure 26. 45° crack in the rear facade of block G

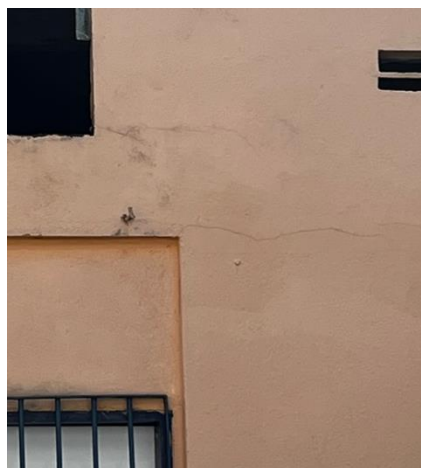
Some horizontal cracks were observed (Figure 27) at the end of spans, possibly caused by deformation of structural components. According to Thomaz [22], in cases where the masonry is supported on reinforced concrete beams, there is a tendency for cracks to be born in this format and propagate in doorways or windows, where the resistant section of the wall is reduced.

Figure 27. Horizontal cracks at gap ends on the rear facade of block G

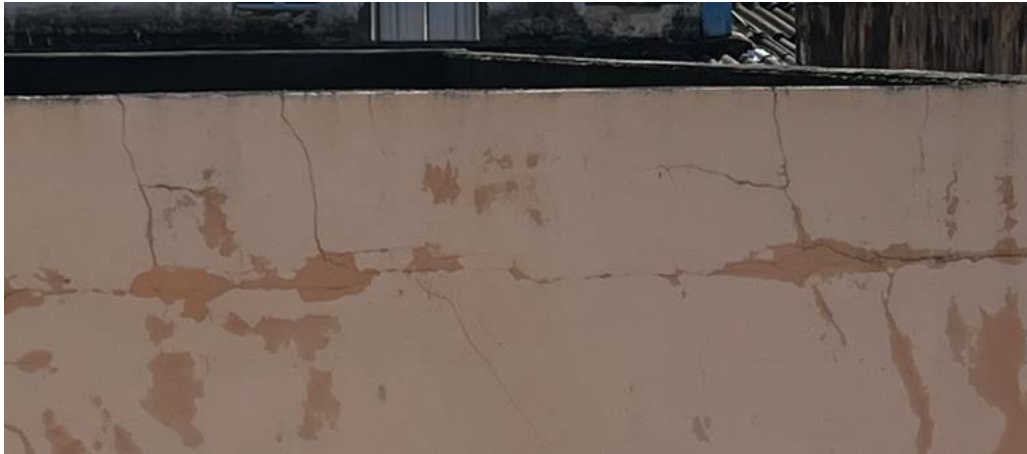
There were spaced vertical cracks (Figure 28) in the platbands of this facade, as well as some horizontal cracks. According to Thomaz [22], platbands function as border walls due to their generally elongated shape. The author states that these vertical cracks arise if movement joints have not been conveniently

designed along them. In the case of horizontal cracks, the differentiated thermal movements between the platform and the building body may be one of the possible causes.

Figure 28. Vertical and horizontal cracks on the back facade of block G

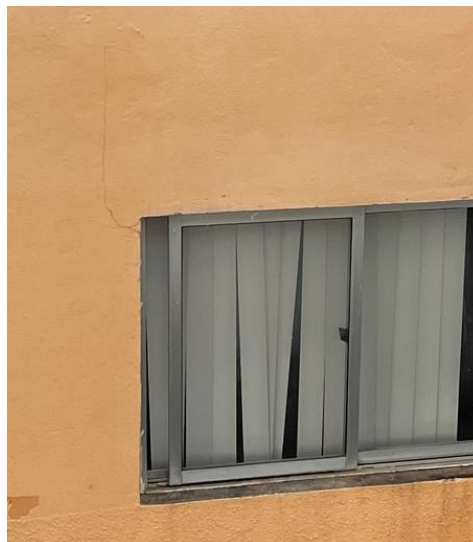
Figure 29 shows a crack in one of the window vertices, in which it is almost completely vertical. This type of crack can be caused due to insufficient strength of the block or the mortar itself.

Figure 29. Vertical crack on the posterior face of Block G

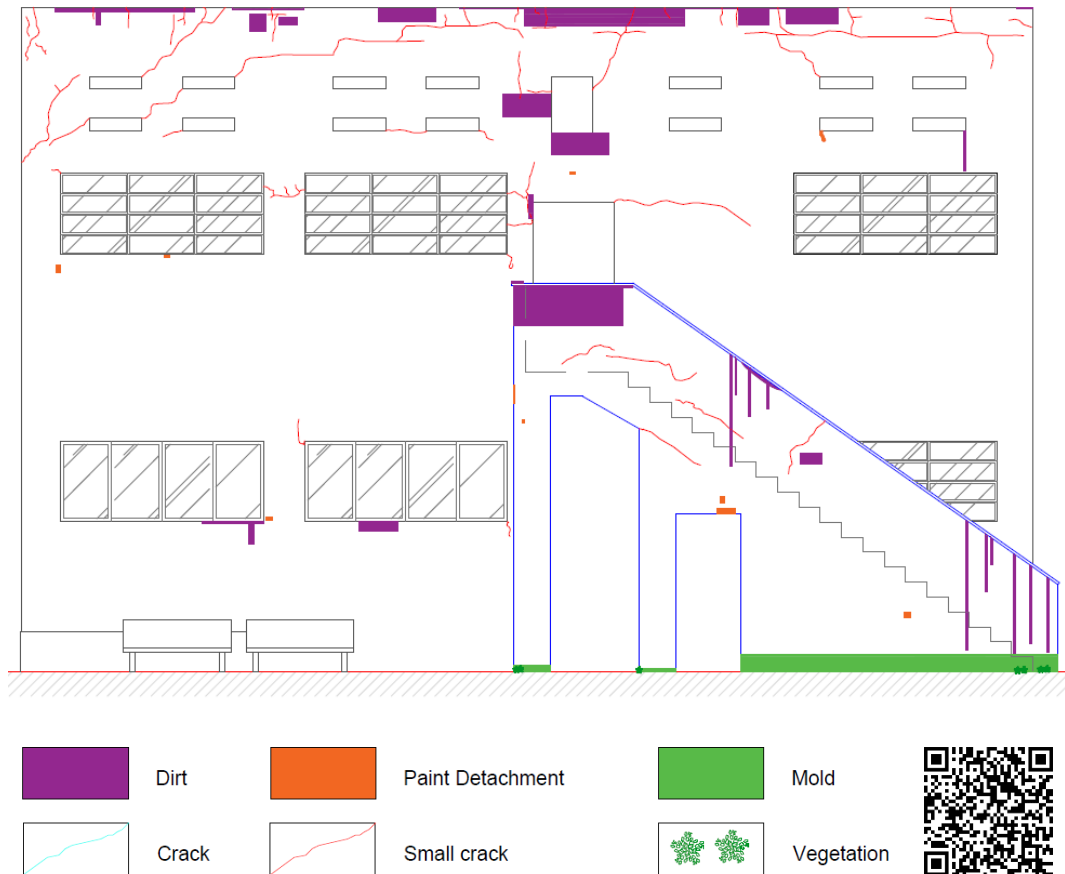
Figure 30 represents the damage map of the rear facade of block G. It is highlighted that, as the space is open, it was possible to photographic record the complete facade, making the final design more accurate. Observing Figure 30 it is possible to verify that this was one of the facades less affected by dirt, mainly justified by its location. This facade presented several types of cracks, mainly in the upper region, in the region of the parapet and the openings. In the lower region of the staircase, located on the right part of the drawing, it is possible to see a significant amount of mold, justified by the presence of a garden with some plants on the site

Figure 30. Damage map of the Rear Façade of block G
