DRILLING RISER INTEGRITY INSPECTION: AN APPROACH USING ADVANCED ULTRASOUND TECHNIQUES

BELTRÃO, Bruno D'Almeida¹, FERREIRA, Carlos Alberto Martins², MUSCI, Marcelo³

ABSTRACT

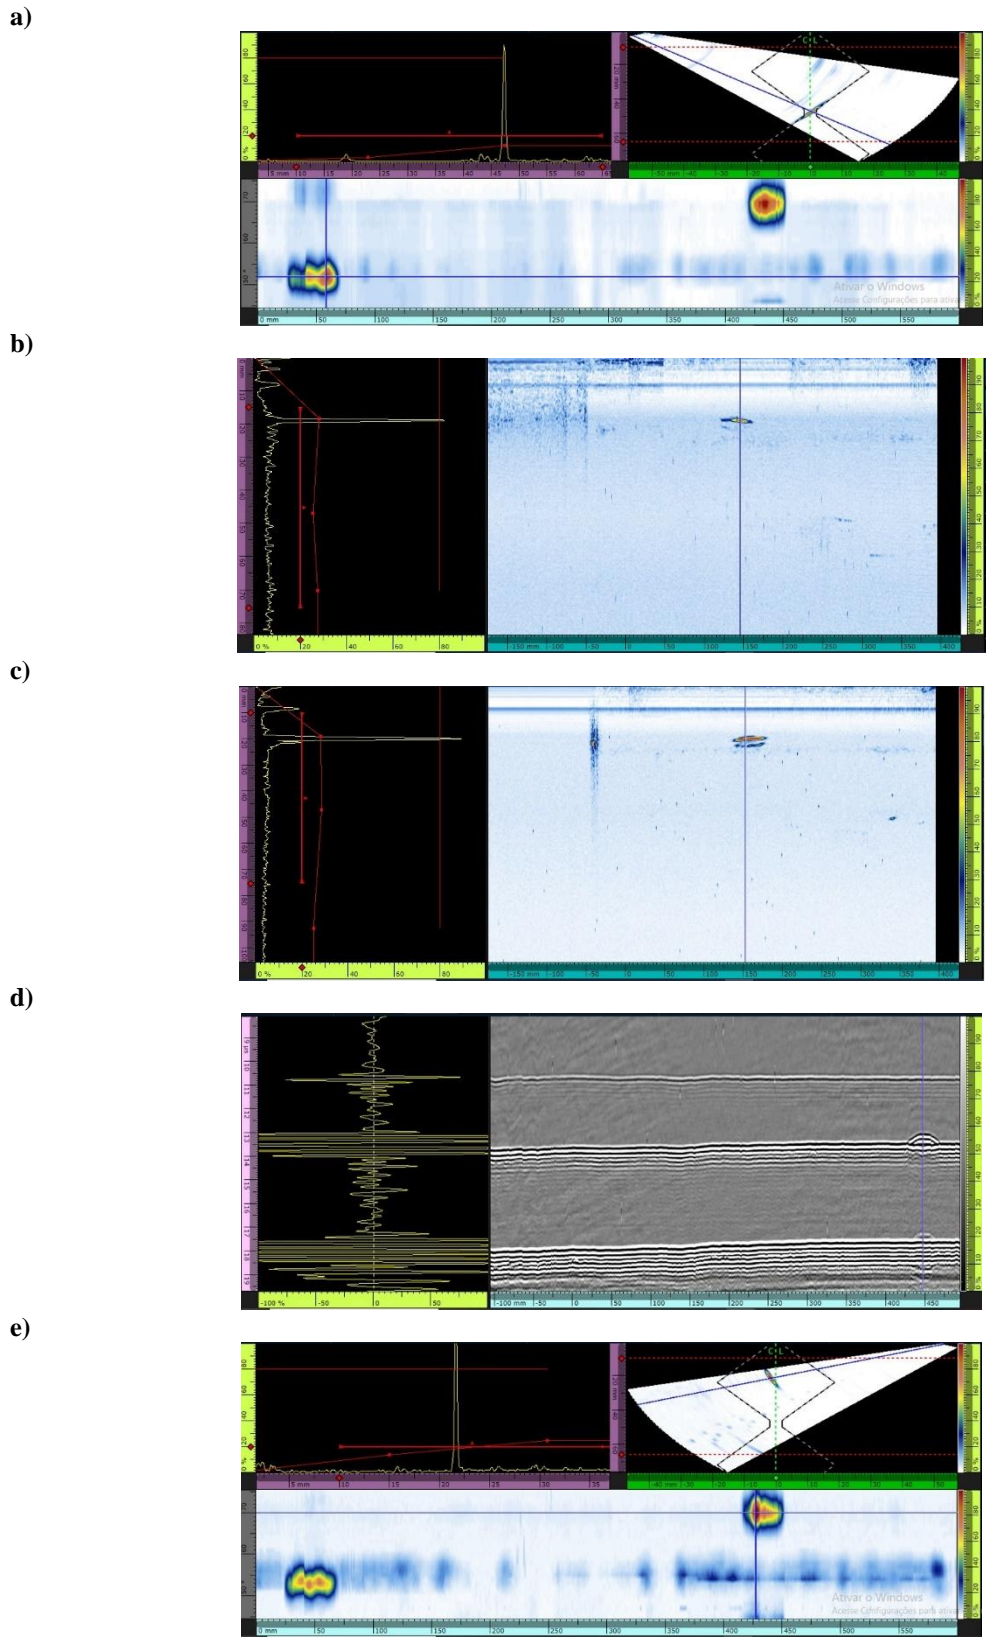
Figure 4. Data files of the girth weld calibration: a) PA1, b) UT1, c) UT2, d) TOFD, e) PA 2

Following the requirements specified in the ASME V article 4 standard [12], all probes were calibrated and had their curves traced. The main pipe weld calibration block was then scanned, and all notches were successfully identified, as shown in Figure 4 (a, b, c, d, e) and Table 4. It is essential to highlight that each technique worked according to the scan plan, where The PA technique swiftly identified the notches that simulated flaws on the internal and external diameters. However, the time-of-flight diffraction technique could only detect the flaw on the exterior surface due to its restriction in detecting discontinuities close to the test surface, and the UT only caught the OD notch once its beam was focused on the weld cap.

Location	PA 1		PA 2		UT 1		UT 2		TOFD	
	Data	Cal. block	Data	Cal. Block	Data	Cal. block	Data	Cal. block	Data	Cal. block
ID notch	32	34	32	34	N/A	34	N/A	34	N/A	34
OD notch	35	34	36	34	35	34	35	34	34	34

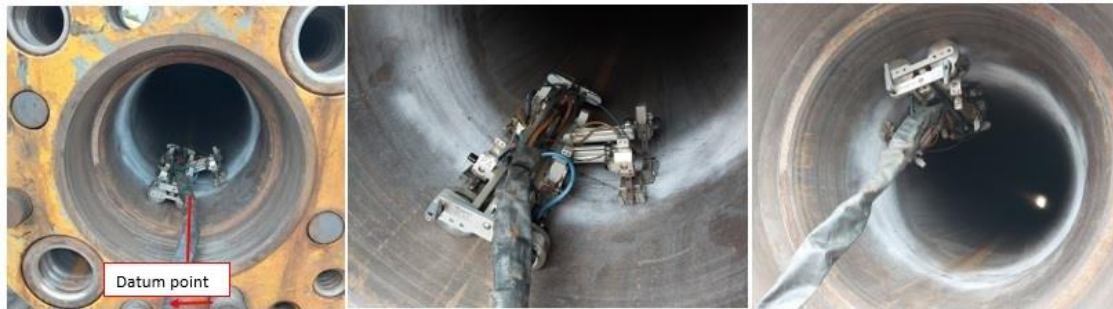
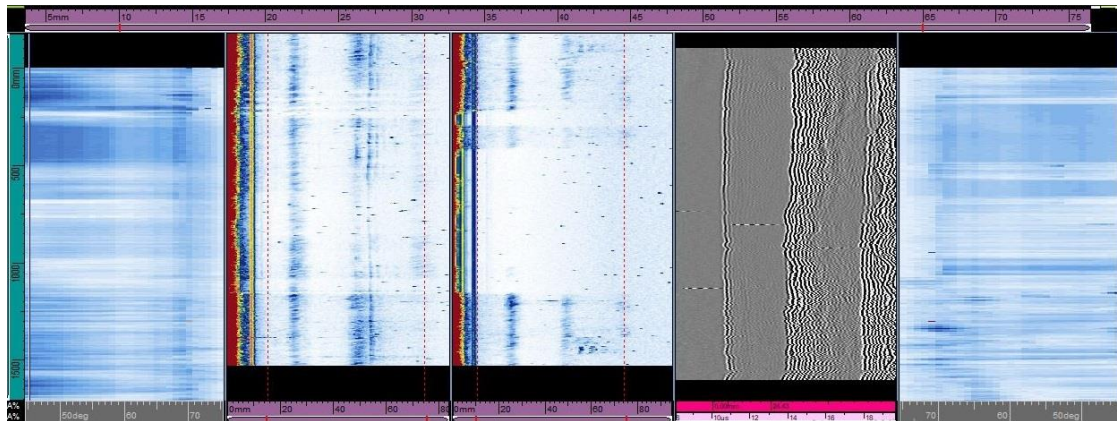
Figure 5. Girth weld inspection on RJ-03: a) Scanning direction and datum point, b) Multiple group view data file (PA1/UT1/UT2/TOFD/PA2)

Pursuing the calibration of each probe and successfully confirming the location of all notches in the block scanning, an inspection was performed on the upper flange weld of RJ-03 (Figure 5). This joint

was previously deemed acceptable after undergoing conventional UT inspection.

During the scanning of RJ-03 using the PA/TOFD/UT scanner, no irregularities or disruptions were identified, aligning perfectly with expectations. However, when turning our attention to RJ-13, the inspection yielded a wealth of information as all expected indications from Table 5 were not only detected but also with an enhanced sensitivity attributed to the amalgamation of various techniques. Figure 6 is the data registered, illustrating indications with a spatial distribution ranging from 0 to 350 mm and 1100 to 1600 mm, values corresponding to the acquisition process's initiation and termination points. The interconnection of these indications is intrinsic to the circumferential nature of the weld, with the acquisition's zero point thoughtfully set at 180° as clarified in Figure 5a.

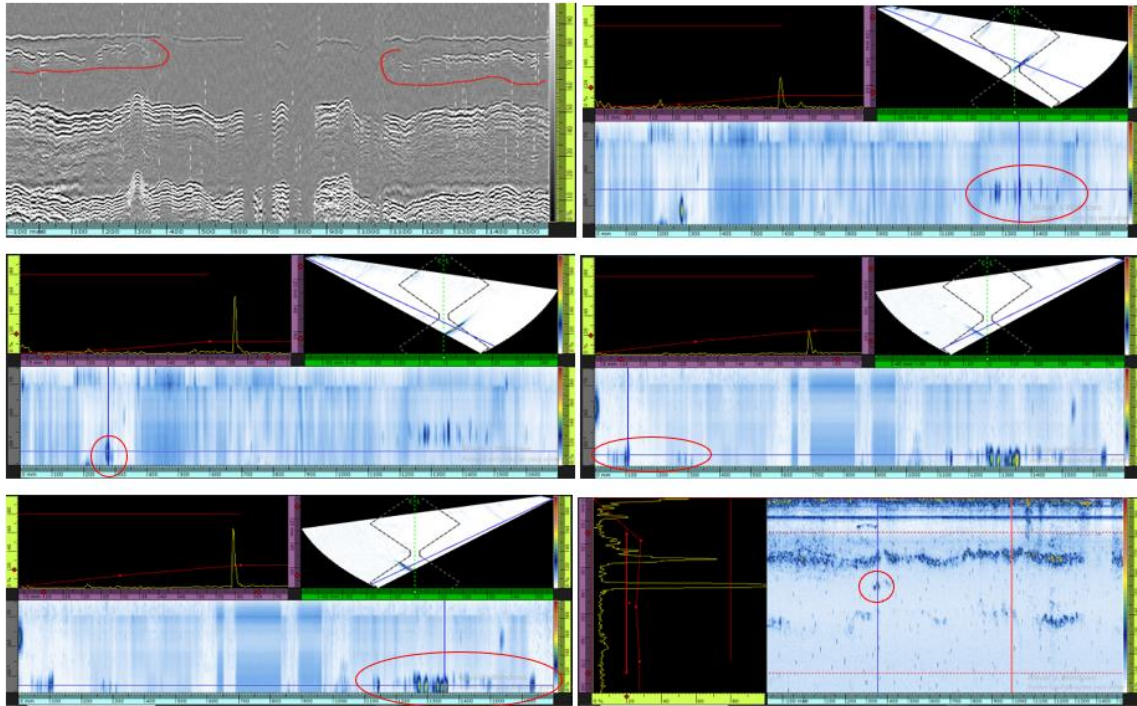
Figure. 6 Joint 13 inspection data files (multi-group)

To thoroughly assess the efficacy of our existing setup and inspection technique in identifying potential indications within the main line girth welds, a detailed examination was conducted on the lower flange weld of RJ-13 (Figure 6). This weld had previously failed conventional UT due to defects located in the datum point area, as outlined in Table 5.

Flaw	Angle	Location (mm)	Result
1	60°	0 to 267	Rejected
2	60°	1260 to 1358	Rejected
3	60°	1390 to 1480	Rejected

Noteworthy is the instrumental role played by the TOFD technique, which demonstrated remarkable sensitivity, pinpointing the expected indications with a more considerable length. Furthermore, this precision was corroborated by observations in the PA1, PA2, and UT datasets, establishing a comprehensive validation of the findings across multiple inspection methodologies.

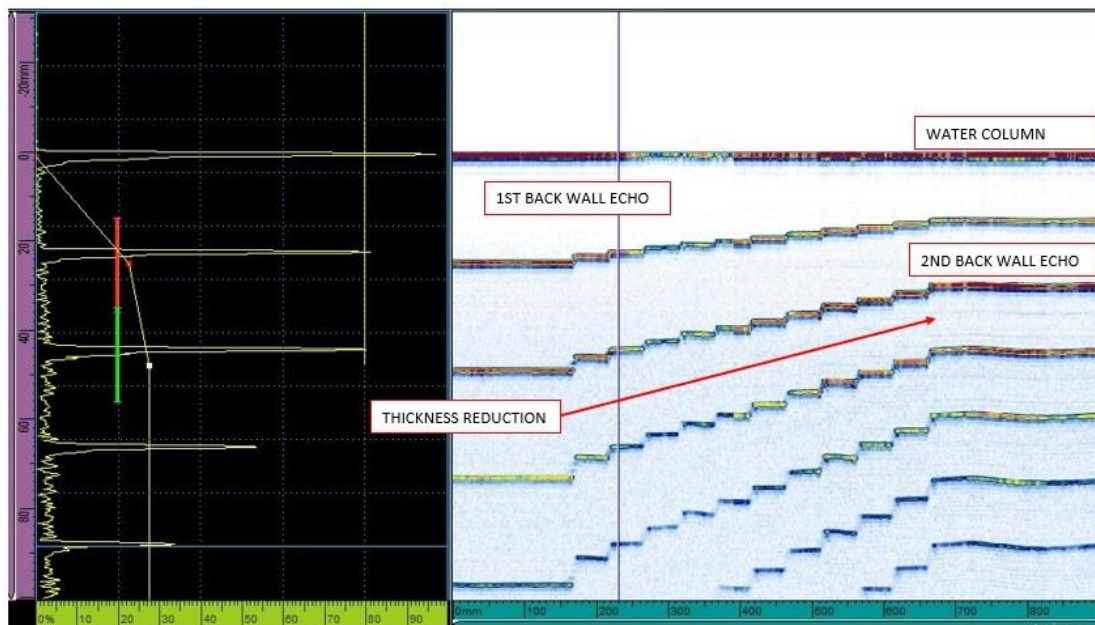
Figure 7. Corrosion mapping calibration block data file

Floating gates were used to monitor two back-wall echoes and the water column, evaluating the thickness losses of the block. The difference between gates A (red) and B (green) was used to analyze the wall thickness, as demonstrated in Figure 7 [8 - 13]

The inspection method effectively pinpointed and cataloged all instances of reduced thickness. A detailed analysis in Table 6 showcases the specific thickness encountered per probe at various stages of the block. These findings illuminate a consistent trend, revealing a standard deviation range between

0.08 and 0.26 mm across the inspected wall. Furthermore, the method exhibited an impressive level of precision, yielding a maximum coefficient of variation of just 1.3%. This meticulous assessment ensures a comprehensive and nuanced visualization of the inspection results.

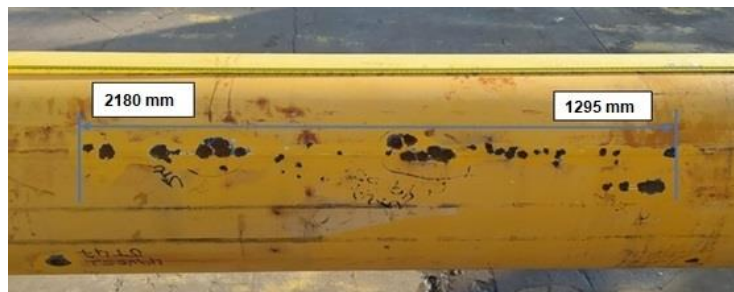
Figure 8. Corrosion mapping inspection: a) PIG going through the tube, b) Corrosion expected to be found.

Following the identification of thickness reductions in the calibration block, the inspection shifted to a corroded pipe, a visual representation depicted in Figure 8b. To commence this thorough inspection process, the assembly of the winch frame onto the riser's flanges marked the initial step. Subsequently, the inspection began by delicately pulling the PIG through the ID of the tube, as visually illustrated in Figure 8a. The primary objective encompassed the corrosion mapping across the pipe's surface, aiming to rigorously evaluate the efficacy of detecting and cataloging all wall thickness loss within the pipe's infrastructure.

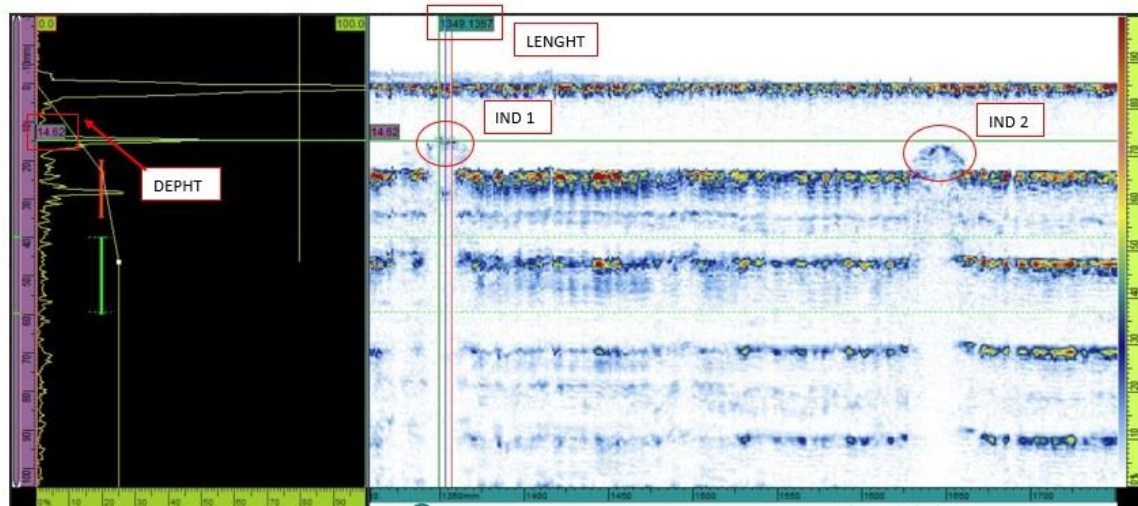
Figure 9. Zoomed view of the corrosion found.

Although the complete inspection data was recorded, the main objective of this inspection was to prove the corrosion identification. Thus, Figure 9 exhibits a zoomed-in view of this area of interest to highlight the data on corrosion detected.

As expected, all meticulously crafted machined reductions of the block were successfully pinpointed during the inspection. However, the configuration of the PIG, with its arrangement of eight probes equidistant at 45° angles, tempered expectations for identifying all indications in the corroded sample. Despite the widespread corrosion in the area, the inspection revealed only two distinct corrosion areas: between 1349 and 1368 mm and 1641 and 1660 mm.

A noteworthy observation emerged during numerous experiments: the PIG displayed a subtle spiral motion while being winch-pulled, altering the probe's beam trajectory responsible for that specific area. Despite concerted efforts to orient the probe towards the corrosion, the remaining indications were undetectable despite persistent attempts.
