CONCENTRATION LEVELS OF LUBRICATING OILS ON CONCRETE FLOORS IN AN INDUSTRIAL LEARNING ENVIRONMENT AND SUBSEQUENT SOIL CONTAMINATION

Vitor Lorival Kudlanvec Junior
Department of Civil Construction,
Federal University of Parana (UFPR), Curitiba, Brazil
vitorlorival86@ufpr.br

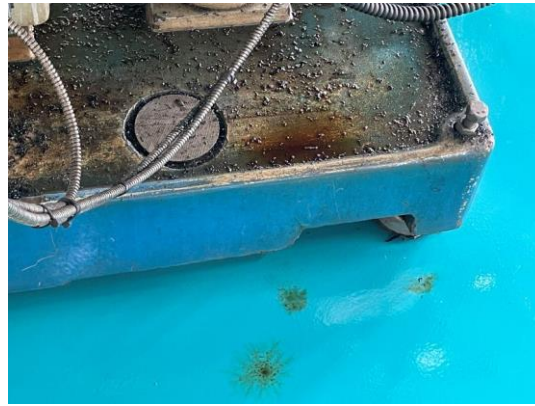
Figure 3 - Lubricating oil in a lathe equipment.

The environment where these pathological manifestations manifest themselves has been operational for a span of 42 years, accommodating equipment such as lathes, bench drills, and others with analogous functions. These apparatuses employ lubricating oil to diminish the coefficient of friction between their mobile elements, thereby mitigating wear and kinetic effort amidst their moving surfaces. Figure 3 illustrates one of the pieces of equipment utilized in the laboratory, showcasing the occurrence of lubricating oil on its surface.

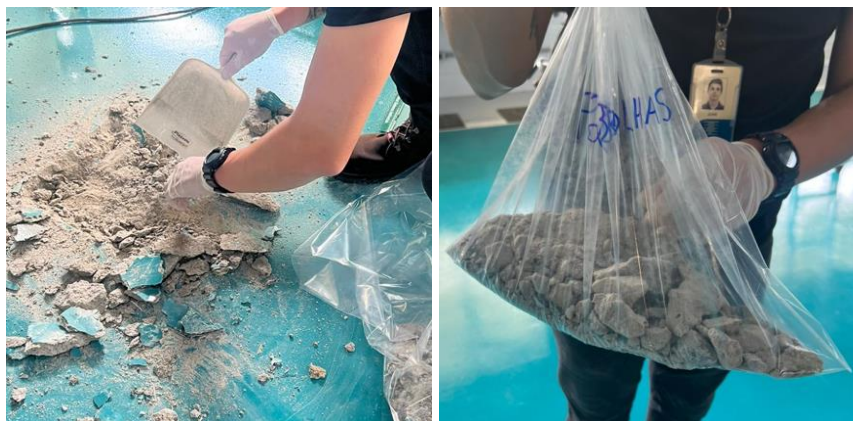
Figure 4 - On-site sample extraction procedure

The conducted tests involved the mechanical extraction of concrete samples obtained from the existing floor. This extraction process took place in two distinct areas: the region characterized by the highest prevalence of oil bubbles (termed the critical region) and a control region devoid of any such manifestations. Each collected unit was meticulously demarcated, with corresponding identification of the removal depth. In the context of this examination, concrete removal depths spanned from 0 to 5 centimetres, 5 to 10 centimetres, and 10 to 15 centimetres. Additionally, part of the graded crushed stone base supporting the concrete floor was extracted. Given the permeable nature of this base, any hydrocarbons present in this layer are considered as contributors to soil contamination beneath the floor. The collection procedure is elucidated in Figure 4, providing a visual representation of the steps involved in gathering the material slated for testing.
