INVESTIGATION OF THE BINDING MATERIALS PROPERTIES AND ASSESSMENT OF DURABILITY ISSUE IN FASIL “GHIBBI” PALACE IN GONDAR, ETHIOPIA

Eskinder Desta Shumuye
Hawassa University, Institute of Technology,
School of Water Recourses Engineering, Ethiopia

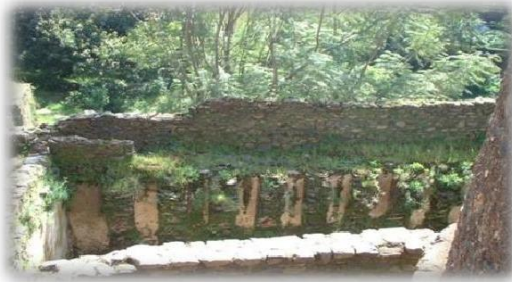
The Royal compound lying within 70,000 m.sq, it encompasses six lofty castles and many different purposed buildings like the royal archive, house of the musicians, the lion cage, the horse zoo, the sauna bath, house of the spinners etc. The earliest and grandest of all edifices is that of Emperor Fasiladas, which is 32 meters high and with battlemented square tower. Today, these historical structures are in different physical state, some are in relatively good condition, while many are in a deplorable state (see figure 1 and figure 2).

Figure 1: Buildings in deplorable state

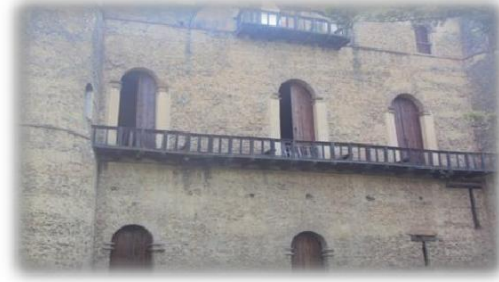
Figure 2: Buildings in good condition

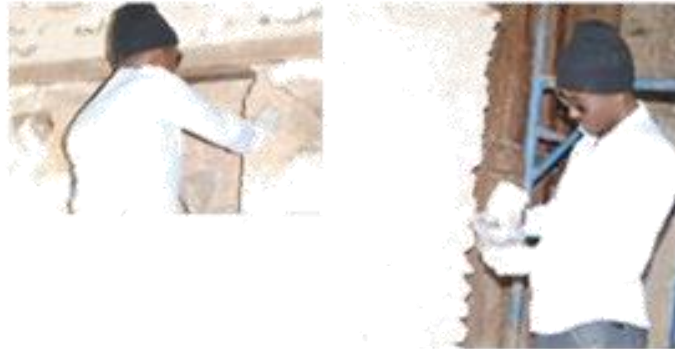
Sample Label: G1

Description: Internal Wall

Weight (gm.): 9.95

Figure 3: Sample taken from the internal wall

Analytical Results for the Original Binding Material in Percent													
Field No.	Lab. No	SiO ₂	Al ₂ O ₃	Fe ₂ O ₃	CaO	MgO	Na ₂ O	K ₂ O	MnO	P ₂ O ₅	TiO ₂	H ₂ O	LOI
G-2	20205/14	35.46	7.98	11.02	18.70	5.48	2.64	<0.01	0.18	0.24	1.80	5.12	12.38

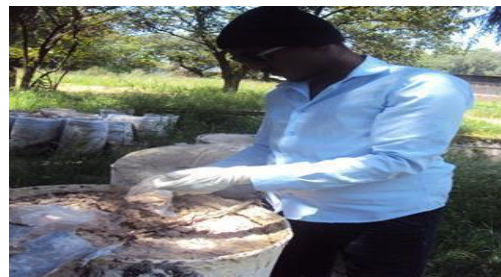
Sample Label: R2

Description: Restoration Site

Weight (gm.): 10

Figure 4: Sample taken from the restoration site

No.	Sample No.	Lab. No.	TW/HWT (gm)	Magnetite	Ilmenite	Ilmonite	Calcite	Quartz	R.F of carbonate and Basalt	Remark
1	G-1	20209/14	10/9.95	Tr	Tr		*50	2	46	*= Clay size Calcite R.F = Rock Fragment Tr =Trace Element

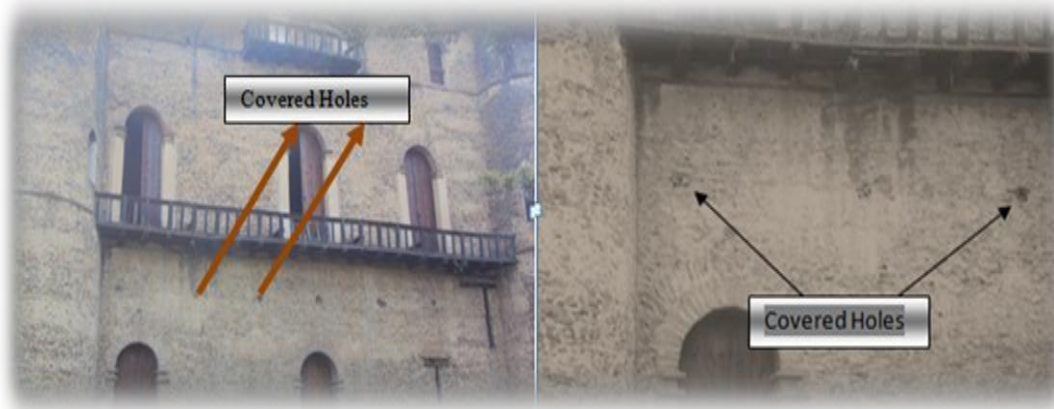
Moreover, considering its height that is 32 meter and accessibility of modern Crane facility; the method of material transportation at the time of construction makes the construction more challenging. However, after inspecting the whole Palace sides, a traditional kind of pulling mechanism were used by the people at that time in order to construct the mason. It has been said that wooden beams were used as a ramp during the masonry construction.

The holes are positioned within 4 to 5 meter distance from the ground and also found within the same interval for the next level of the wall of the palace.

As it is seen in the (picture 5), it is possible to observe the holes. Meanwhile the holes were covered by the same kinds of stone probably at the end of construction for the aesthetical purposes. However, anyone can physically observe that the covered holes for the wooden beams are visible on different sides of the walls.

Figure 5: Covered holes for the wooden beams in the main Castel.

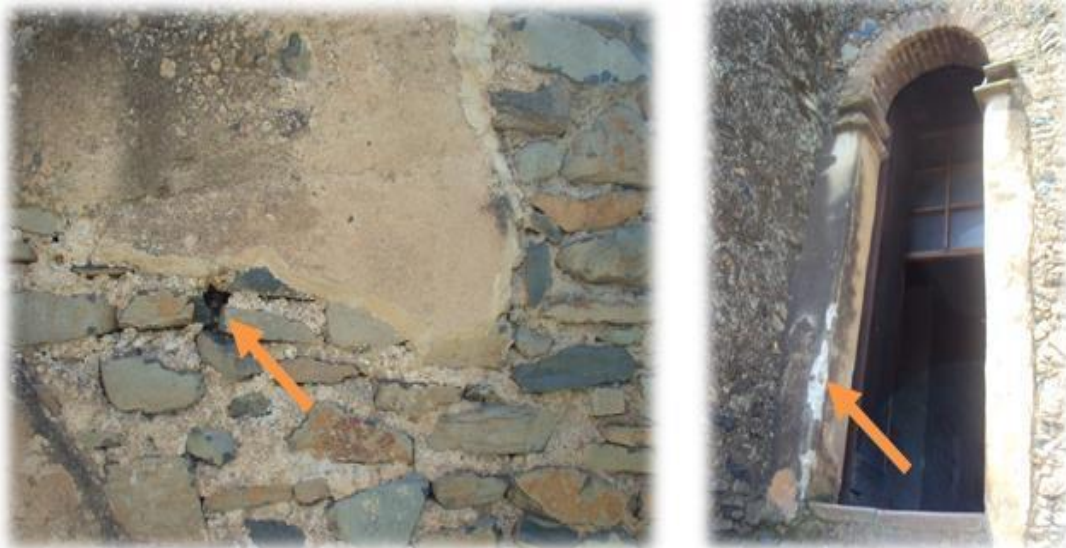
It is well known that various deterioration mechanisms, due to environment interaction with building materials, can occur, in which water always plays a primary role.

Figure 6: Deterioration of rendering Mortar

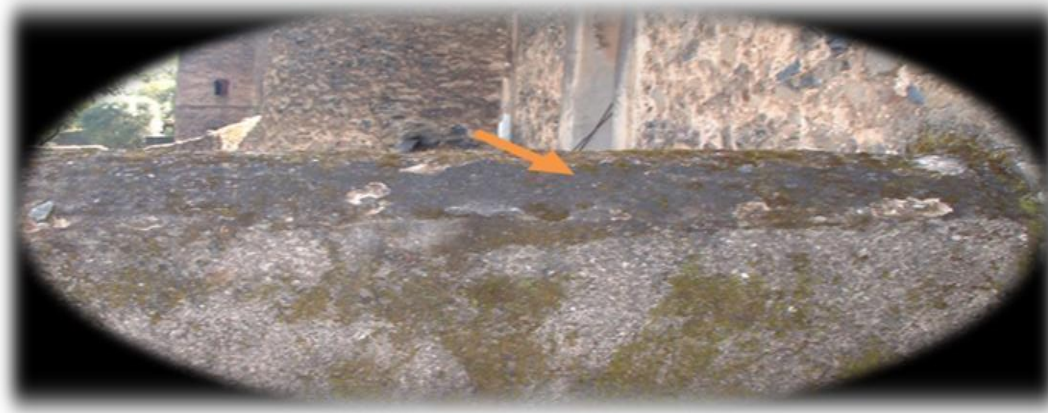
- II. ***Chemical causes***: Due to ettringite and/or thaumasite production as a result of the reaction between sulfate salts and hydrated calcium silicates or aluminates which are present in mortars based on hydraulic lime or lime-pozzolanas; and (See the Figure below).

Figure 7: Mortar deterioration due to Chemical Reaction

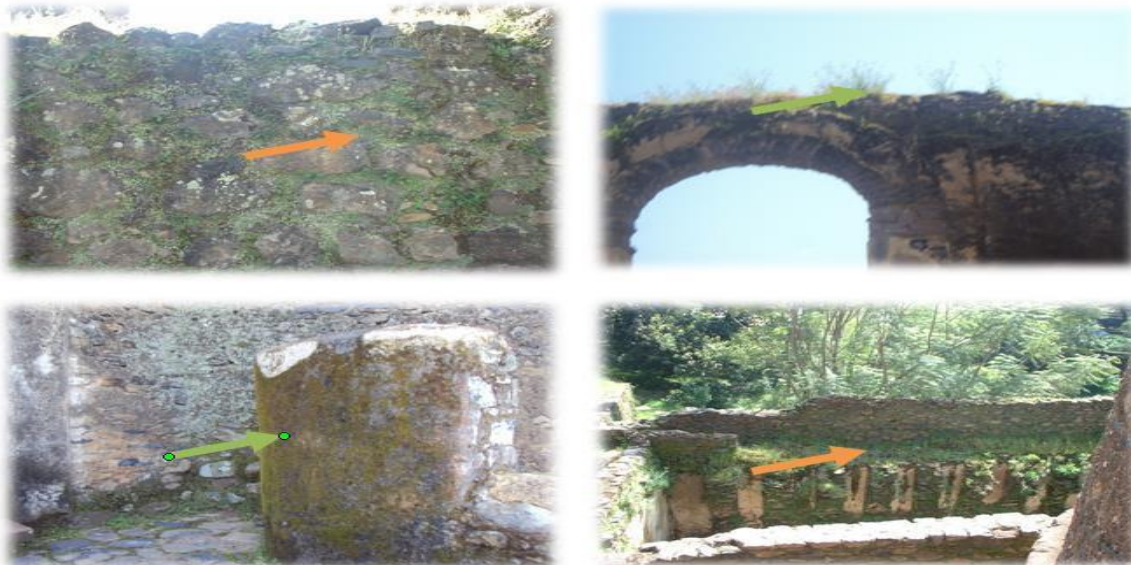
- III. ***Biological causes***: As in the case of formation of algae, lichens and fungi. These specific causes have been the chief problem in the external face of the walls.(See the Figure below)

Figure 8: Mortar deterioration due to Biological Causes

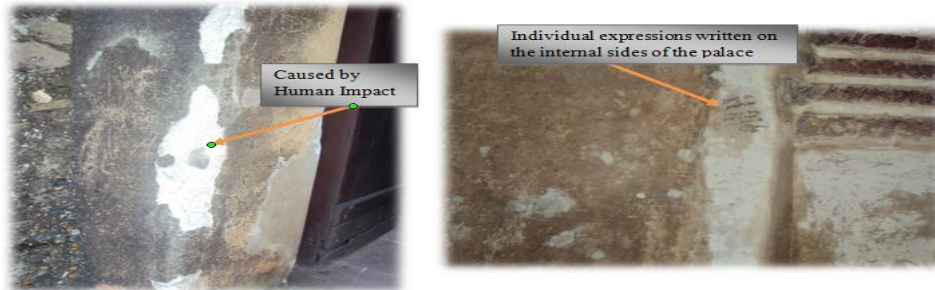
- IV. ***Mechanical actions***: E.g. impact, overloading, vibration, blasting etc. hence the Royal Palace is located on the center of the city, vibration which is prompted by the nearby traffic load is one of the problems. Proper follow up and care has to be on check points, it is better to limit the number of visitors at a time for proper monitoring and reducing the mechanical impact caused by some irresponsible individuals. (See the Figure below)

Figure 9: Mortar deterioration due to Mechanical action

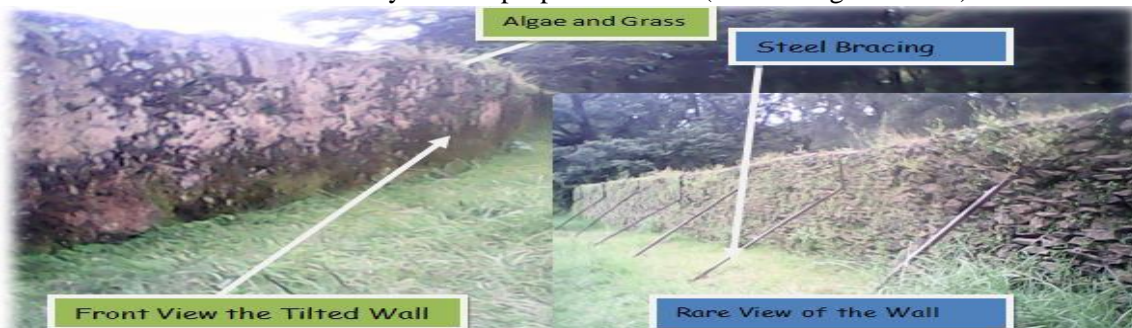
The major case for leaning of the masonry wall in the royal palace may perhaps due to the existence of algae, shrub and different kind of Grass on unusual part of the wall. Lack of proper follow-up; for the last time restoration activities and restoration practices was done in the past around 1989 in collaboration with UNESCO.

Hence the upper portion of the wall was leaning out of plumb. Masonry damage was the result of aging of the structure and materials, poor water proofing, wrong loading conditions like vibration due to traffic load etc. The destabilization of older walls due to the deterioration of the inner core rubble between the exterior and interior faces of masonry needed proper attention. (See the Figure below)

Figure 10: Leaning Of the Masonry Wall in the Royal Palace Near to the Main Road

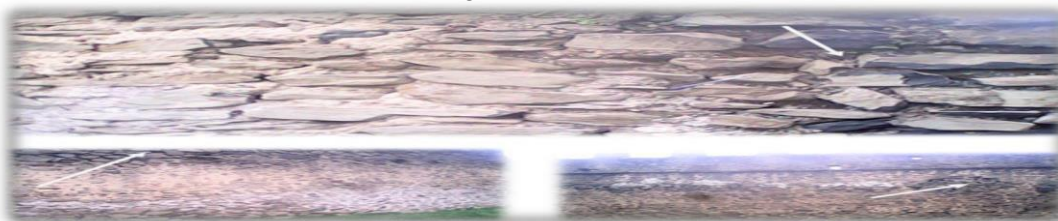
The second dilemma which is related to durability issue of the Royal palace is the loose bondage of mortar in between the masonry stone layer and also the removal of the top pointing surface due to a number of reasons; in addition to the above listed impact mechanical impact caused by human beings should also have to be considered. (See the figure below)

Figure 11: Mortar re-pointing in the internal and external appearance of the palace wall
