INSPECTION OF PATHOLOGICAL MANIFESTATIONS WITH EXECUTION OF DAMAGE MAP IN FACADES: CASE STUDY IN BLOCK G OF POLYTECHNIC SCHOOL OF PERNAMBUCO

José Maria de Moura Júnior and Yêda Vieira Póvoas

Escola Politécnica de Pernambuco, Universidade de Pernambuco, Rua Benfica, 455, Madalena, Recife-PE, 50720-001, Brasil

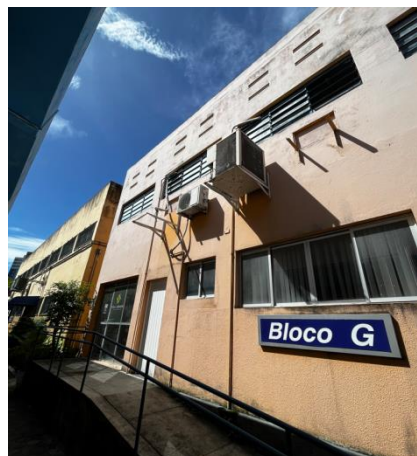
Figure 1. Front facade of block G

It was possible to verify dirt on the upper part of the facade in large amounts, although of low In addition, small stains were also observed around the windows, some at the top as seen in Figure 2,

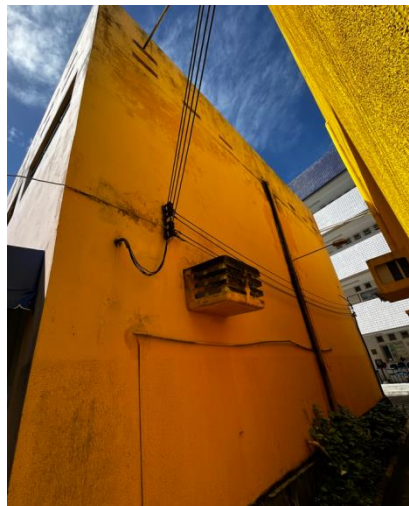
Figura 8. Right side facade of block G

This facade presented dirt, mainly on the upper part (Figure 9). In addition, this pathological manifestation was also identified near the left pillar and at the base of the structure.

In the central region of the facade there is an external pipe that runs from the garden at the bottom to almost the top of the facade. There was dirt around the pipe (Figure 10), probably caused by some leakage at the top.

Along the facade, paint detachment was verified, as in Figure 11, which shows the detachment near the left end pillar, and in Figure 12, which shows it near the garden. In addition, other points were verified, seen in the damage map at the end.

A horizontal crack was observed on the upper part of the facade that runs along the entire length of the structure (Figure 13). The crack is above the window, possibly at the structure-masonry interface, between the beam and the masonry.

As on the previous facade, 45% cracks were found in the openings on the upper part of the facade (Figure 14 and 15), some with greater length than others.

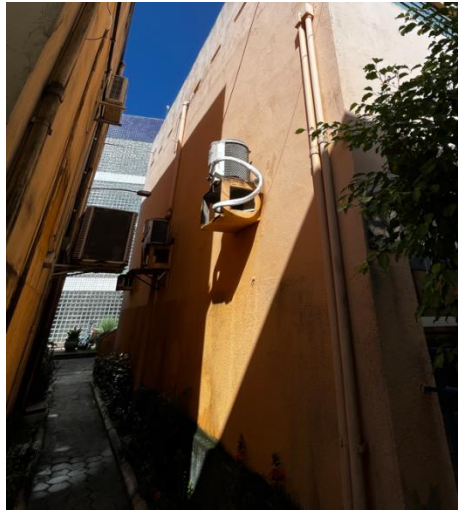
Figure 17. Left side facade of block G

Along the facade it was observed detachment of the paint, especially in some points near the garden (Figure 18), located at the bottom of the facade.
