DRILLING RISER INTEGRITY INSPECTION: AN APPROACH USING ADVANCED ULTRASOUND TECHNIQUES

BELTRÃO, Bruno D'Almeida¹, FERREIRA, Carlos Alberto Martins², MUSCI, Marcelo³

ABSTRACT

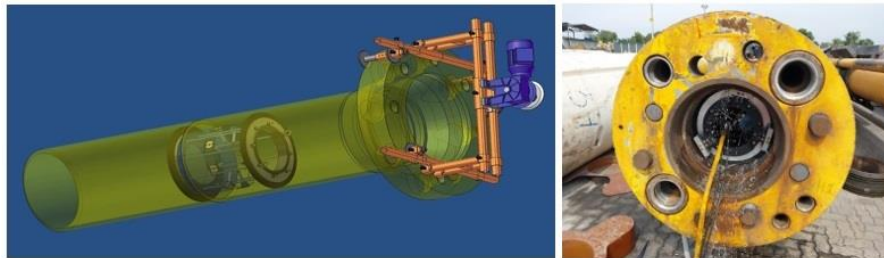
Following the identification of thickness reductions in the calibration block, the inspection shifted to a corroded pipe, a visual representation depicted in Figure 8b. To commence this thorough inspection process, the assembly of the winch frame onto the riser's flanges marked the initial step. Subsequently, the inspection began by delicately pulling the PIG through the ID of the tube, as visually illustrated in Figure 8a. The primary objective encompassed the corrosion mapping across the pipe's surface, aiming to rigorously evaluate the efficacy of detecting and cataloging all wall thickness loss within the pipe's infrastructure.

Figure 8. Corrosion mapping inspection: a) PIG going through the tube, b) Corrosion expected to be found.
